WESTCOUNTRY RIVERS TRUST CITIZEN SCIENCE

MONITORING OF THE PAR RIVER AND ITS TRIBUTARIES

MAY 2022

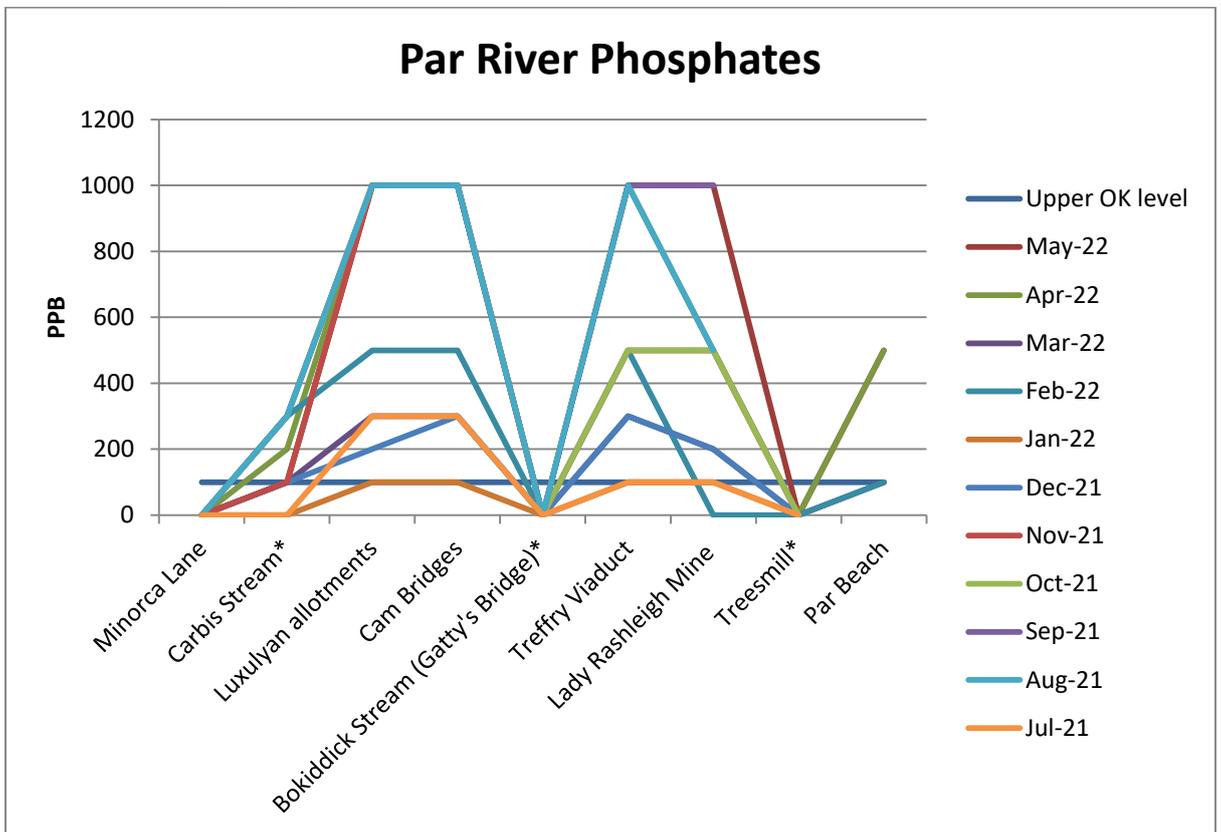
This chart shows that since July 2021 phosphate levels in most of the 9 monitoring points have exceeded the threshold of what is acceptable ('OK') according to Westcountry Rivers Trust guidelines. Our belief is that high phosphate levels are linked to the St Austell North Sewage Treatment Works at Luxulyan.

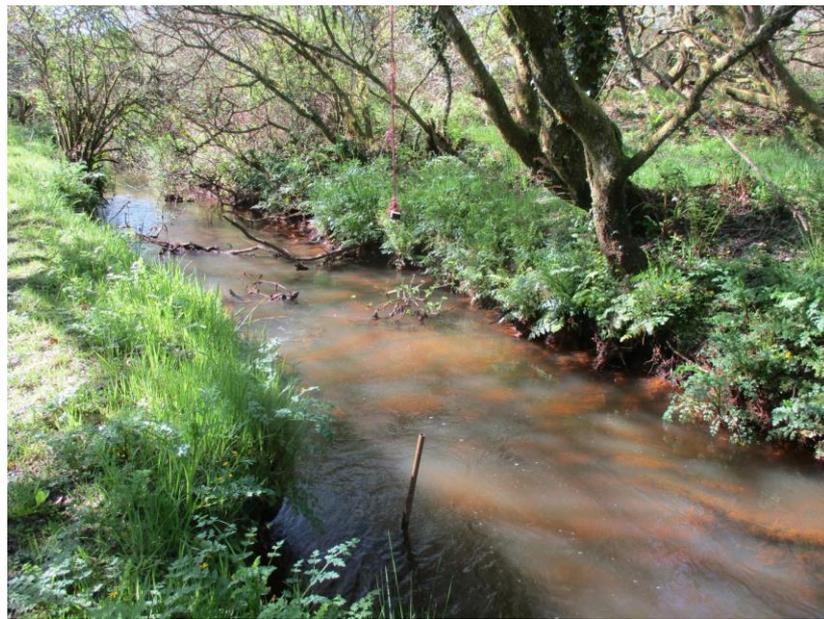
Sampling point near Minorca Lane SX 02657 59788

LOCATION	E.coli MPN/100 ml	Total Coliforms MPN/100 ml
Par River south of Minorca Lane, Par River (SX 02657 59788)	>1000 Very Unsafe	>1000 Very Unsafe

Joan Farmer reported that: 'The sample was taken on 7/5/2022. Results on 9/5/2022. The weather was sunny with only very light rain in the last 24 hours.'

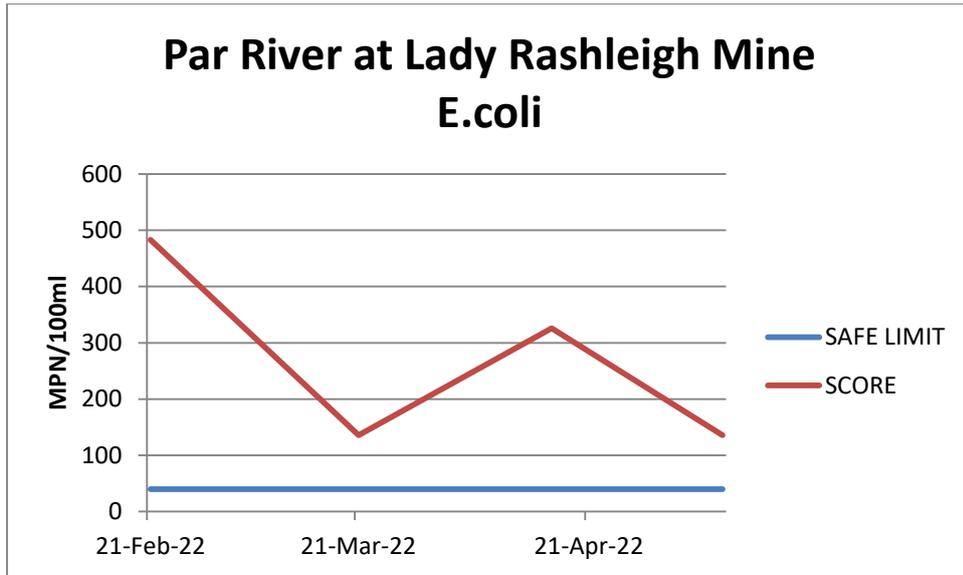
- (i) E.coli was 136 MPN/100 ml, which is considered to be **High Risk/Probably Unsafe**.

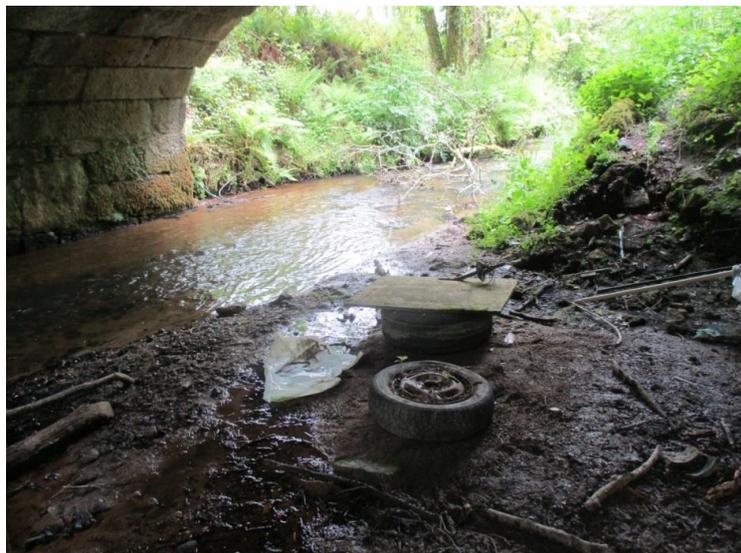
1. No evidence was found under canal bridge at Pons Mill (SX 07312 56164). This may be because of disturbance and the dumping of rubbish (see photo).

Rubbish under Pons Mill canal bridge. This was removed.

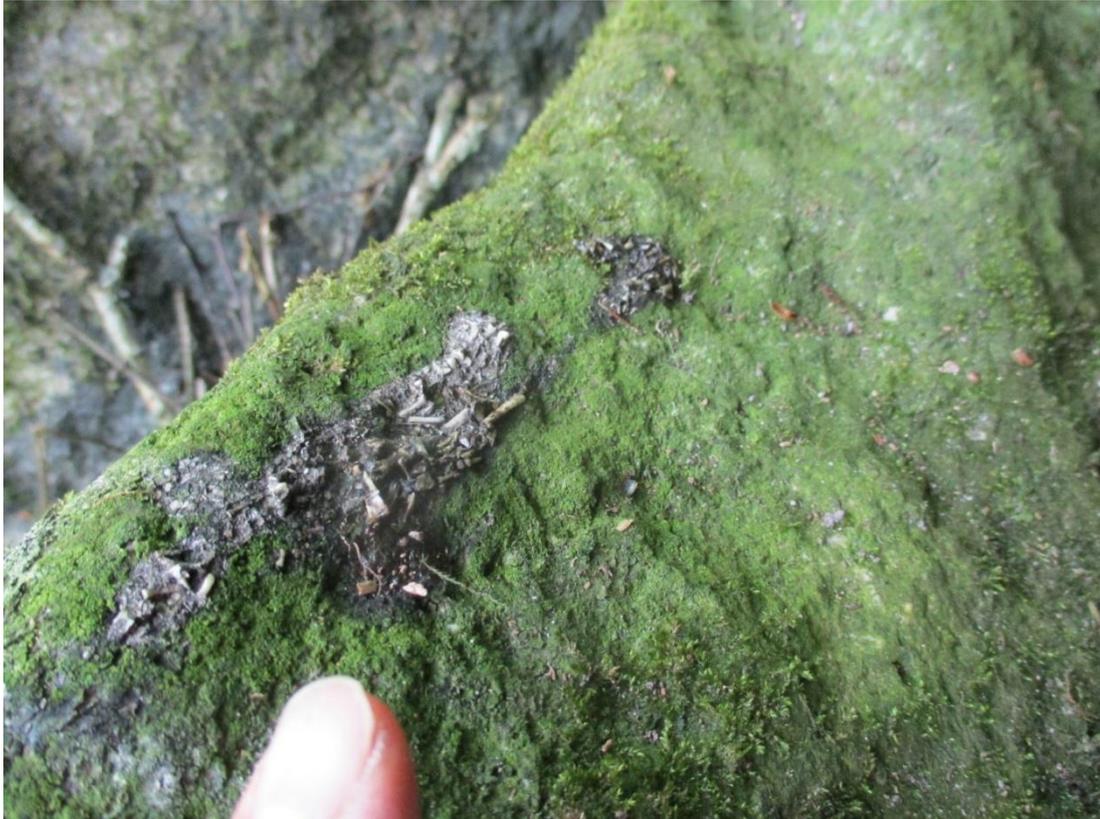
2. Old spraint on the boulder at Lady Rashleigh Mine (SX 06456 56498). It is thought to have been deposited since the last survey in April.

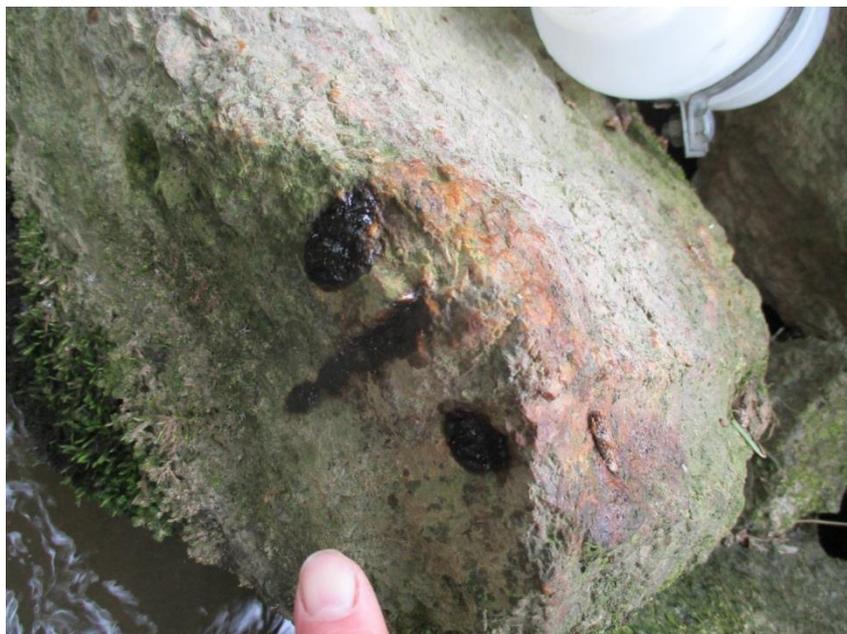
3. Recent spraint at Luxulyan allotments (SX 04747 58056).

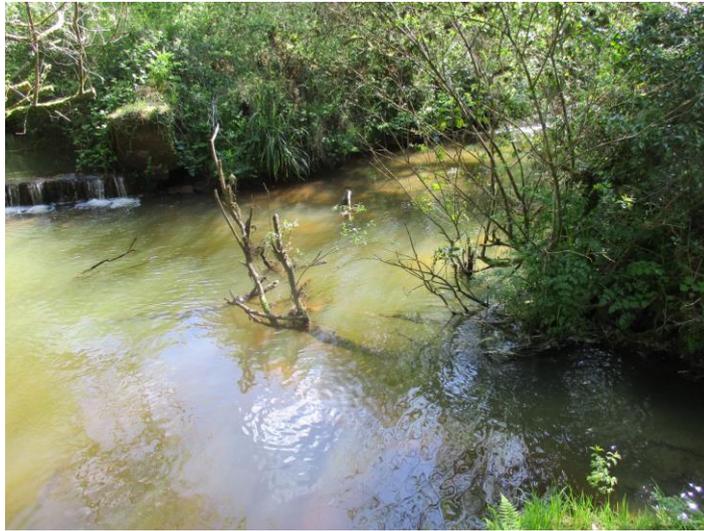
- (a) The variety of wildlife spotted was greater than usual, including fish, otter spraint, dippers, grey wagtails, damselflies, pond-skaters.
- (b) The Carbis Stream was relatively clear (see photo).

Carbis Stream just downstream from SX 02834 59401. Usually the white Carbis Stream (on the right) is white where it joins the main river on the left.
