WESTCOUNTRY RIVERS TRUST CITIZEN SCIENCE

MONITORING OF THE PAR RIVER AND ITS TRIBUTARIES

MAY 2022

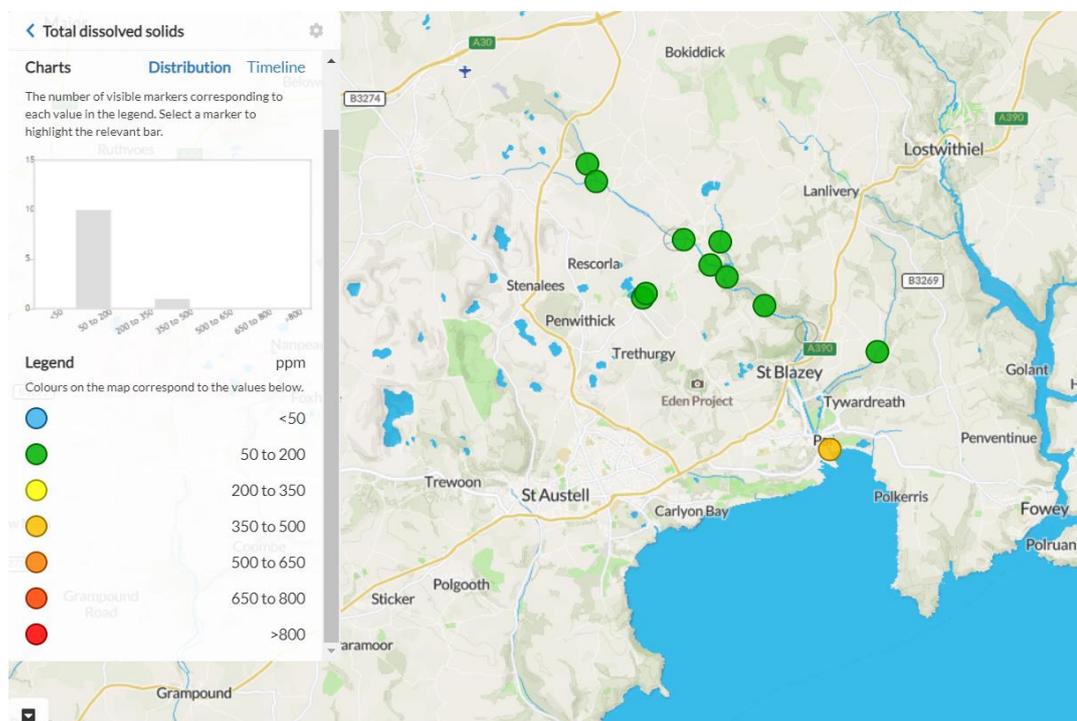
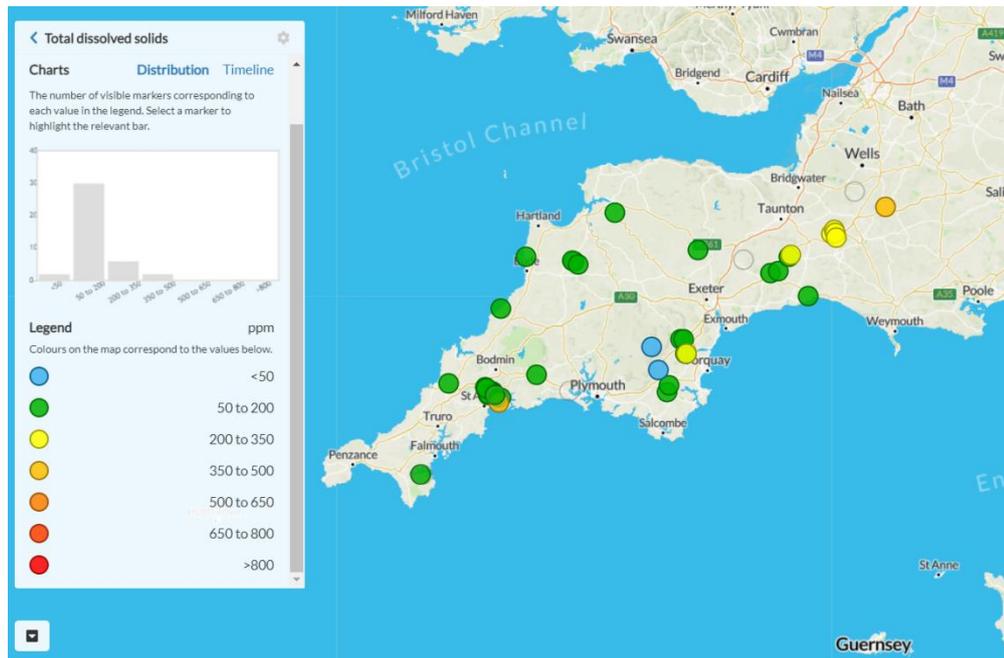
The score of 455 ppm for Total Dissolved Solids at Par Beach is the highest ever recorded by this group. It could reflect sand in suspension because of the state of the tide or a malfunction of the TDS device.

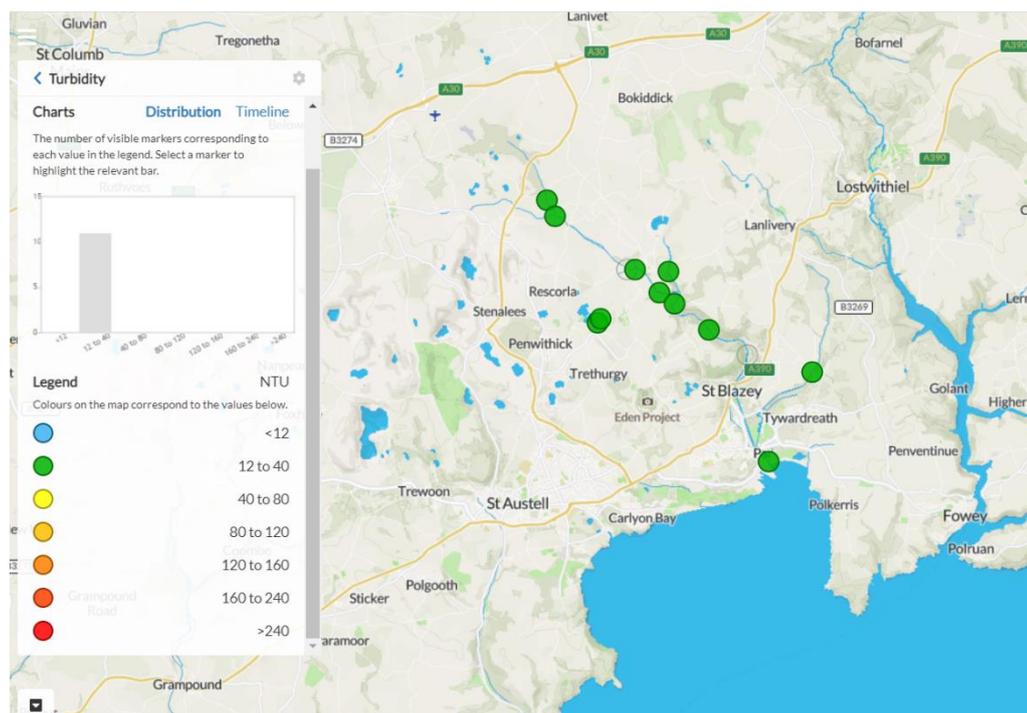
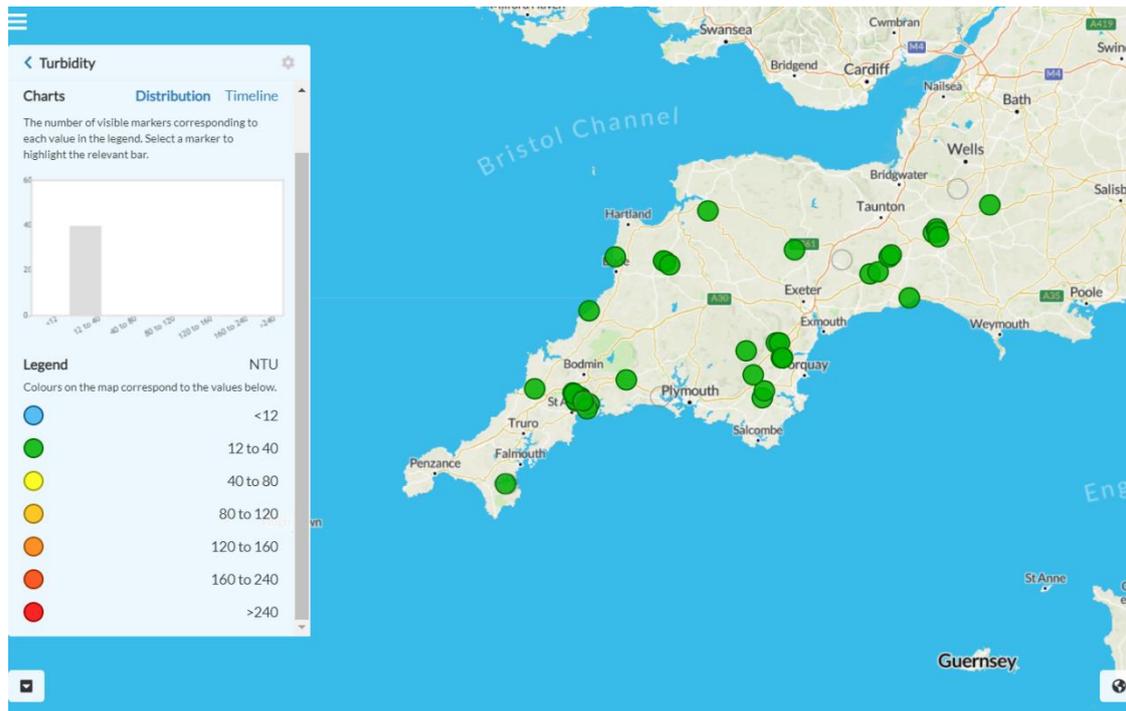
2. **Geographical comparison.** Where scores are shown as 0, it means that the reading using the Secchi tube was <12. Source: Cartographer.

The low turbidity at Par Beach is surprising given the elevated reading for Total Dissolved Solids.

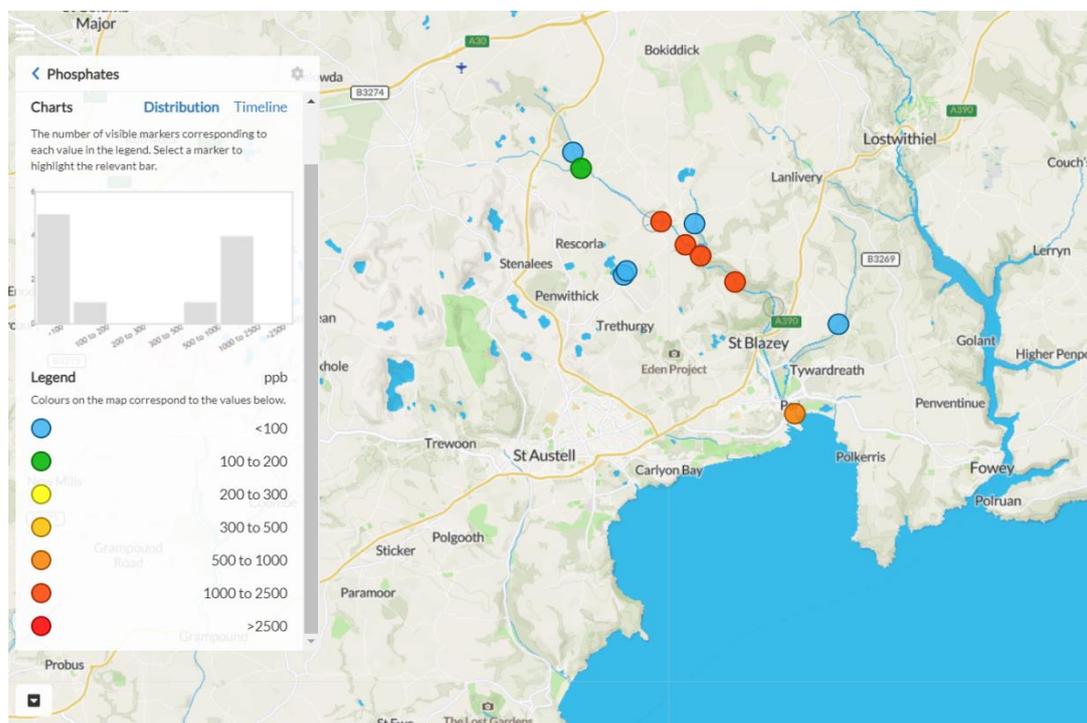
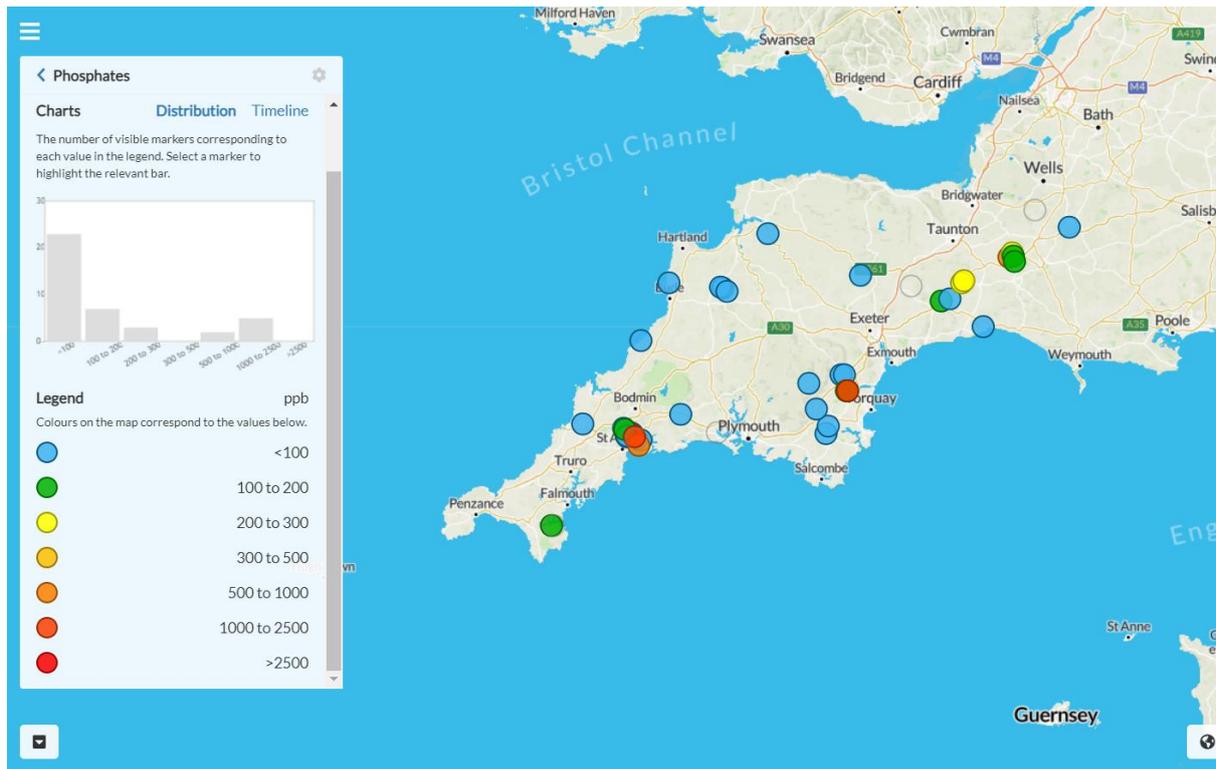
WRT advises that levels up to 100 ppb are OK. Only at 4 of the 9 locations was the level at 100 ppb or lower.

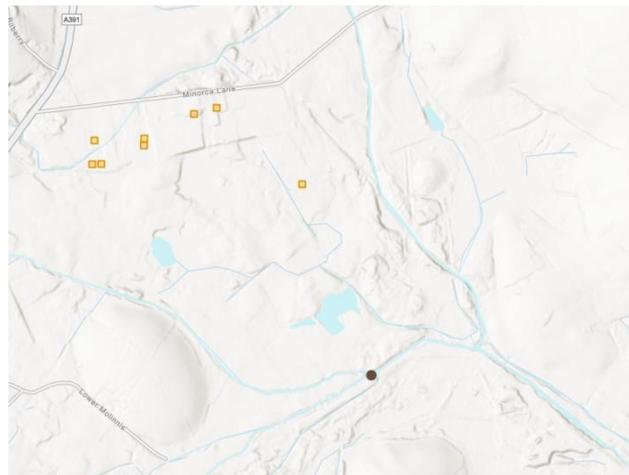
In the following map (taken from The Rivers Trust's Sewage Map at <https://theriverstrust.org/key-issues/sewage-in-rivers>) the sampling point was on the river to the east of the easternmost square.

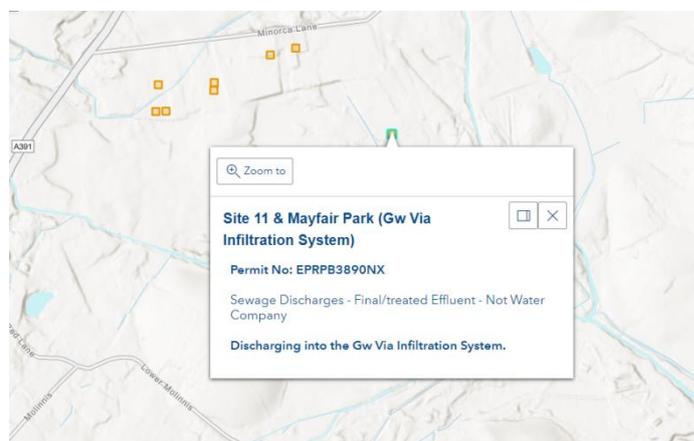
Each square indicates sewage discharges not provided by water companies. One such is shown:

The proximity of 8 permitted sewage discharges into groundwater via an infiltration system may be unrelated to the elevated levels of bacteria. It **does not** mean that the permitted sewage discharges are having any impact on water quality in the Par River. Our group has **no evidence** to suggest that they do and **no suggestion or implication** is being made. However, if bacteria levels are high in this section of the river (and elsewhere), one factor to look is possible seepage from non-water company sewage discharges. It would be interesting to sample for bacteria closer to the source of the river, perhaps in the Criggan Moors area.

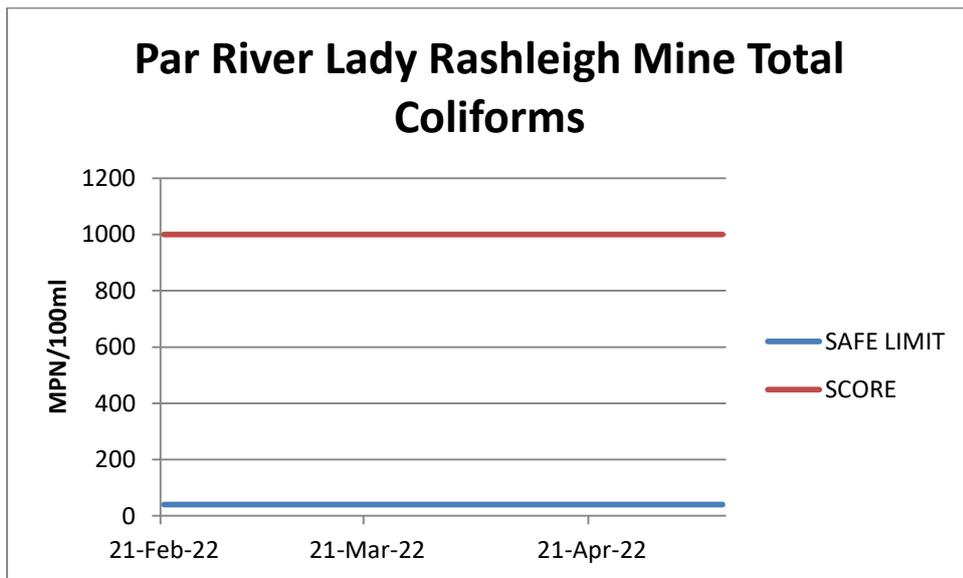
(ii) Total Coliforms

Also: The Aquagenx interpretation table has a category of >1000 MPN/100ml. This has been shown on the graph as 1000.

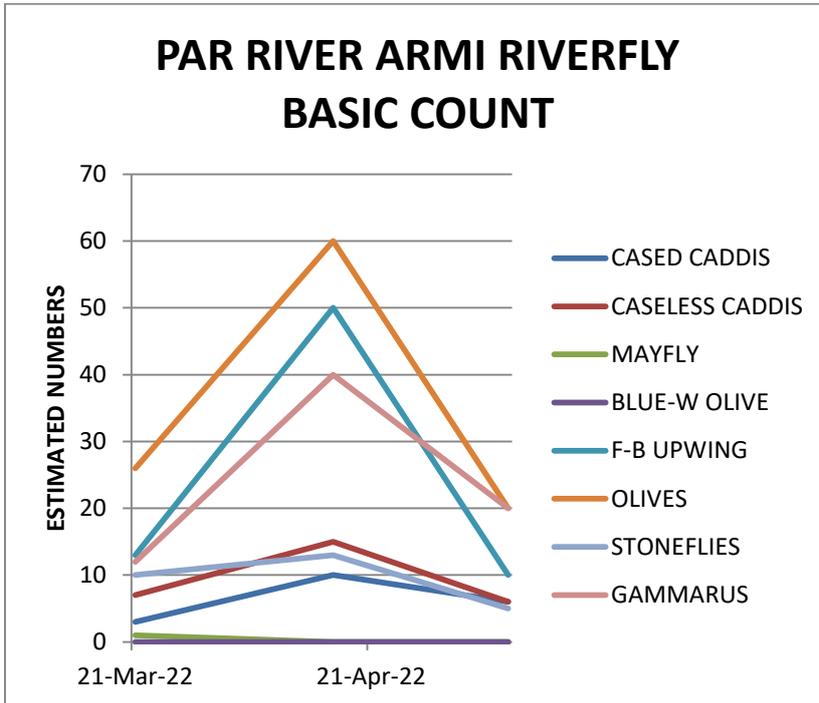
CATEGORY TOTAL	9
TRIGGER LEVEL	6

Whether due to the reduction in time taken with the survey, warmer weather or other unknown factors, the category total fell below that achieved in previous months.
